# THESIS

LOW ENERGY IMPACT LOADING OF GRAPHITE-EPOXY PLATES

Richard Lee Ferris

December 1976

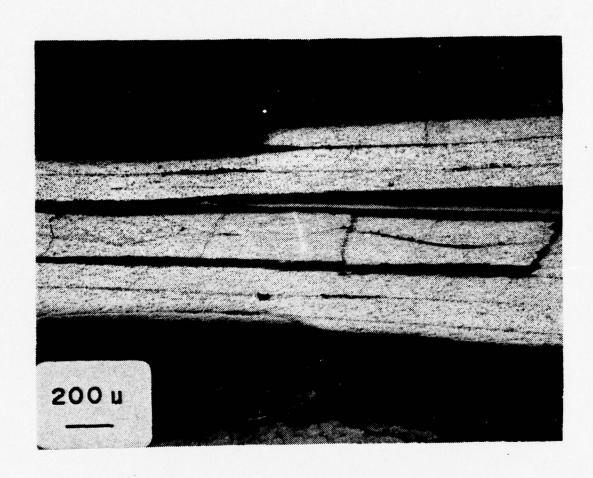
Figures 22, 23, and 24 show the lamina in the gross delamination region. These show extensive delamination, and numerous large cracks in the matrix, between fibers, penetrating entire laminas. Each delamination between laminas appears to have at least one crack penetrating the lamina directly above or below. Figure 24 illustrates this, with delaminations and associated fractures of the adjacent laminas.

Totally flexural failure damage should have been concentrated in the outermost layers where the largest stresses occurred. Figures 22, 23, and 24 all demonstrate a significant failure of the middle two layers in their

Figure 22 - LIGHT MICROSCOPE, FAILURE SURFACE EXAMINATION, SECTION 1A3, 100x

Figure 23 - LIGHT MICROSCOPE, FAILURE SURFACE EXAMINATION, SECTION 1A3, 50X

Figure 24 - LIGHT MICROSCOPE, FAILURE SURFACE EXAMINATION, SECTION 1A3, 200x

transverse direction. The assumption that the middle surface of the plate did not experience extension, therefore, is invalid. This would indicate that theoretical analysis based on small deflection theory is inappropriate.

It appears the lack of strength of the laminas in the transverse direction was the significant factor in failure of these plates. Adding 90 degree laminas might have provided a large increase in impact resistance and static strength.
